*Urban Flood Damage Reduction and Channel Restoration Development  
and Demonstration Program for Arid and Semi-Arid Regions (UFDP);  
Southwest Urban Flood Damage Program (SWDP)*

## **Rio Grande Lidar Bank Erosion Monitoring: Preliminary 2007-2008 Results and Survey Design Considerations**

Tim F. Wawrzyniec, Jed D. Frechette, Julie Coonrod,  
and John Stormont

September 2010

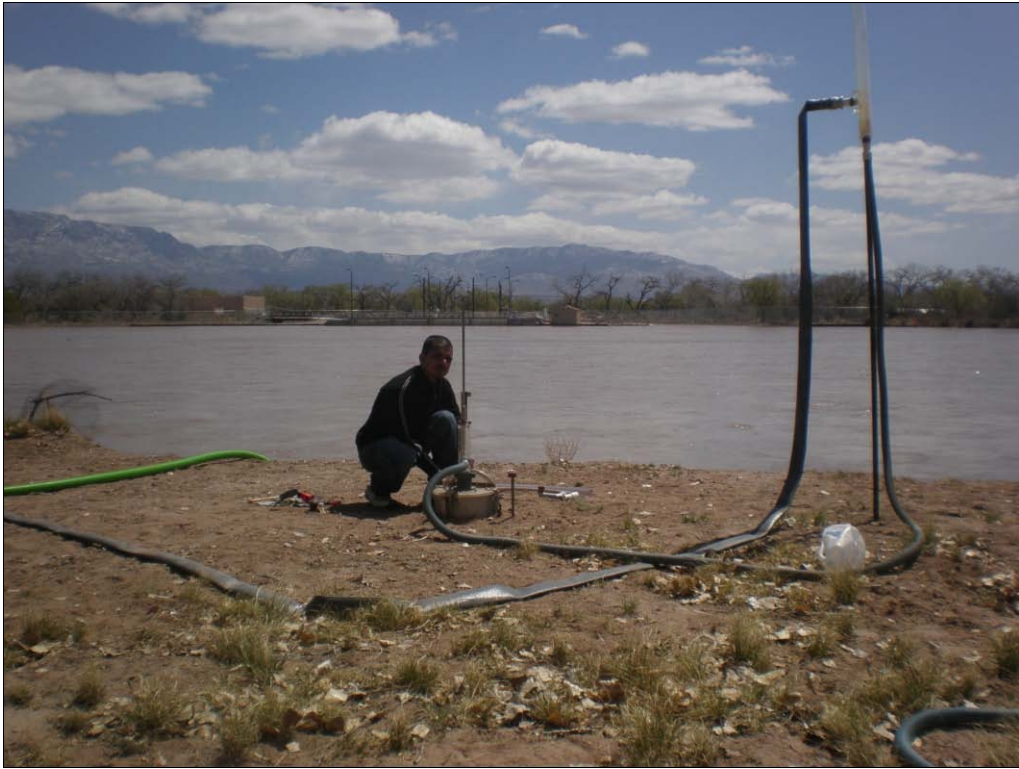
Figure 1. Photograph of submerged jet apparatus being used near San Juan Chama Drinking Water Project diversion dam. Submergence tank is in middle of photograph with standpipe used to generate constant head to right.

A photograph of the jet erosion apparatus is shown in Figure 1. The principal component of the apparatus is a cylindrical, open-bottomed submergence tank that is driven into the ground. Water is introduced into the top of the tank by means of a nozzle that creates a jet of water. The water erodes or scours the soil in the bottom of the submergence tank. A point gage is used to measure the depth of scour as a function of time and head used to create the jet. A standpipe fed by a pump is used to supply water under the desired value of head. Scour depth versus time data is interpreted to provide estimates of critical shear stress (the initiation of erosion) and erodibility (erosion rate). The scour created by the jet device at the conclusion of a test is shown in Figure 2.

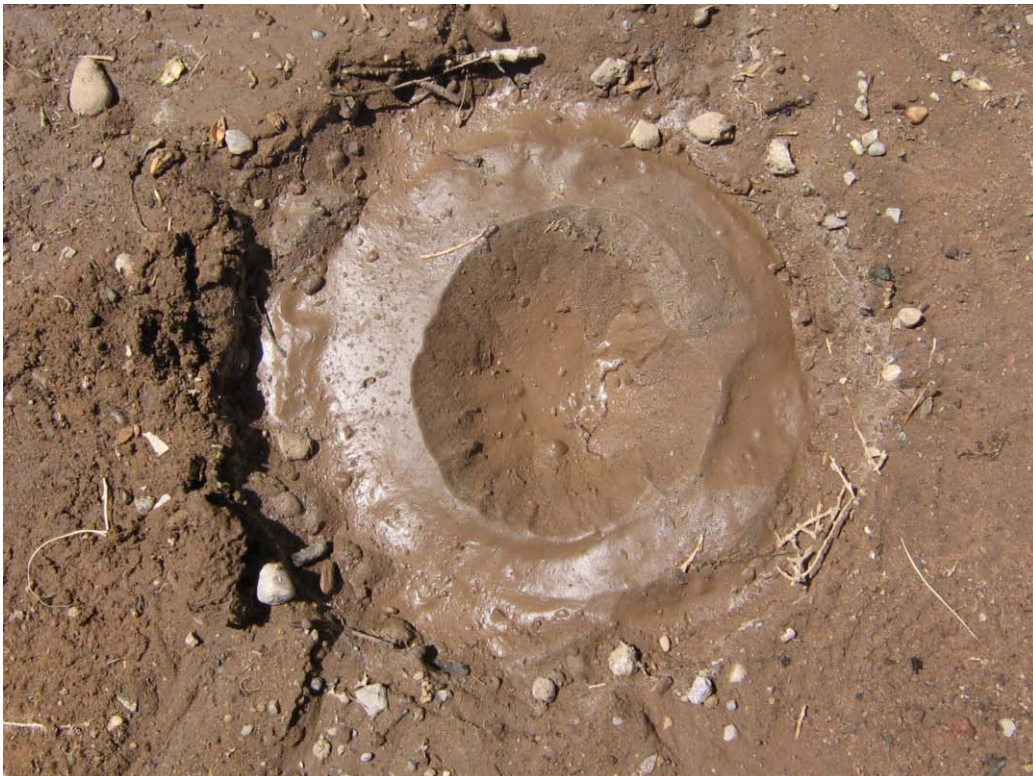
Figure 2. Observed scour at conclusion of test using submerged jet erosion apparatus.
